# **Debris/Ice/TPS Assessment and Integrated Photographic Analysis of Shuttle Mission STS-101**

**DEBRIS/ICE/TPS ASSESSMENT  
AND  
INTEGRATED PHOTOGRAPHIC ANALYSIS  
OF  
SHUTTLE MISSION STS-101**

**19 May 2000**

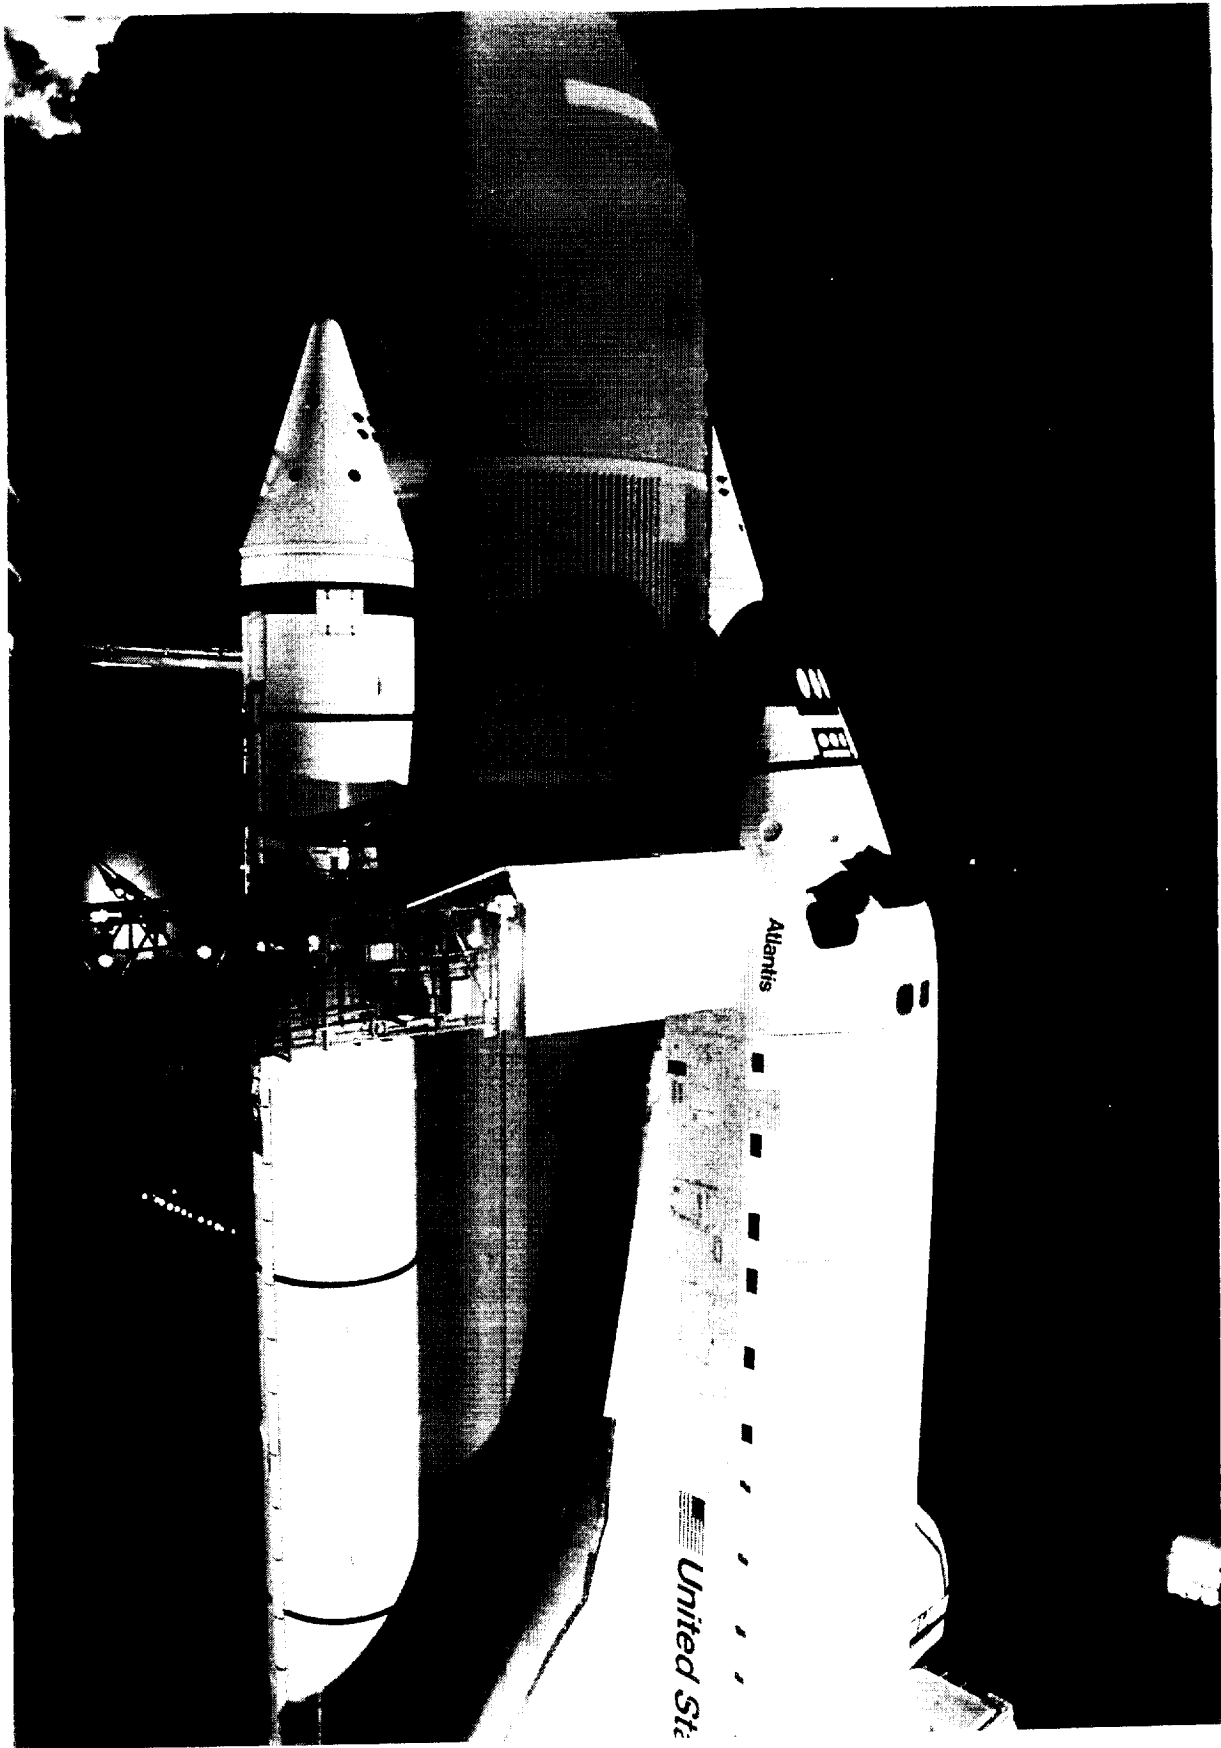
**Photo 5: ET LO2 Tank and Intertank**

During this fourth cryoload, the External Tank was in excellent condition. The Final Inspection Team observed light condensate on the LO2 tank acreage. Surface temperatures averaged 57 degrees Fahrenheit. No TPS anomalies were detected.

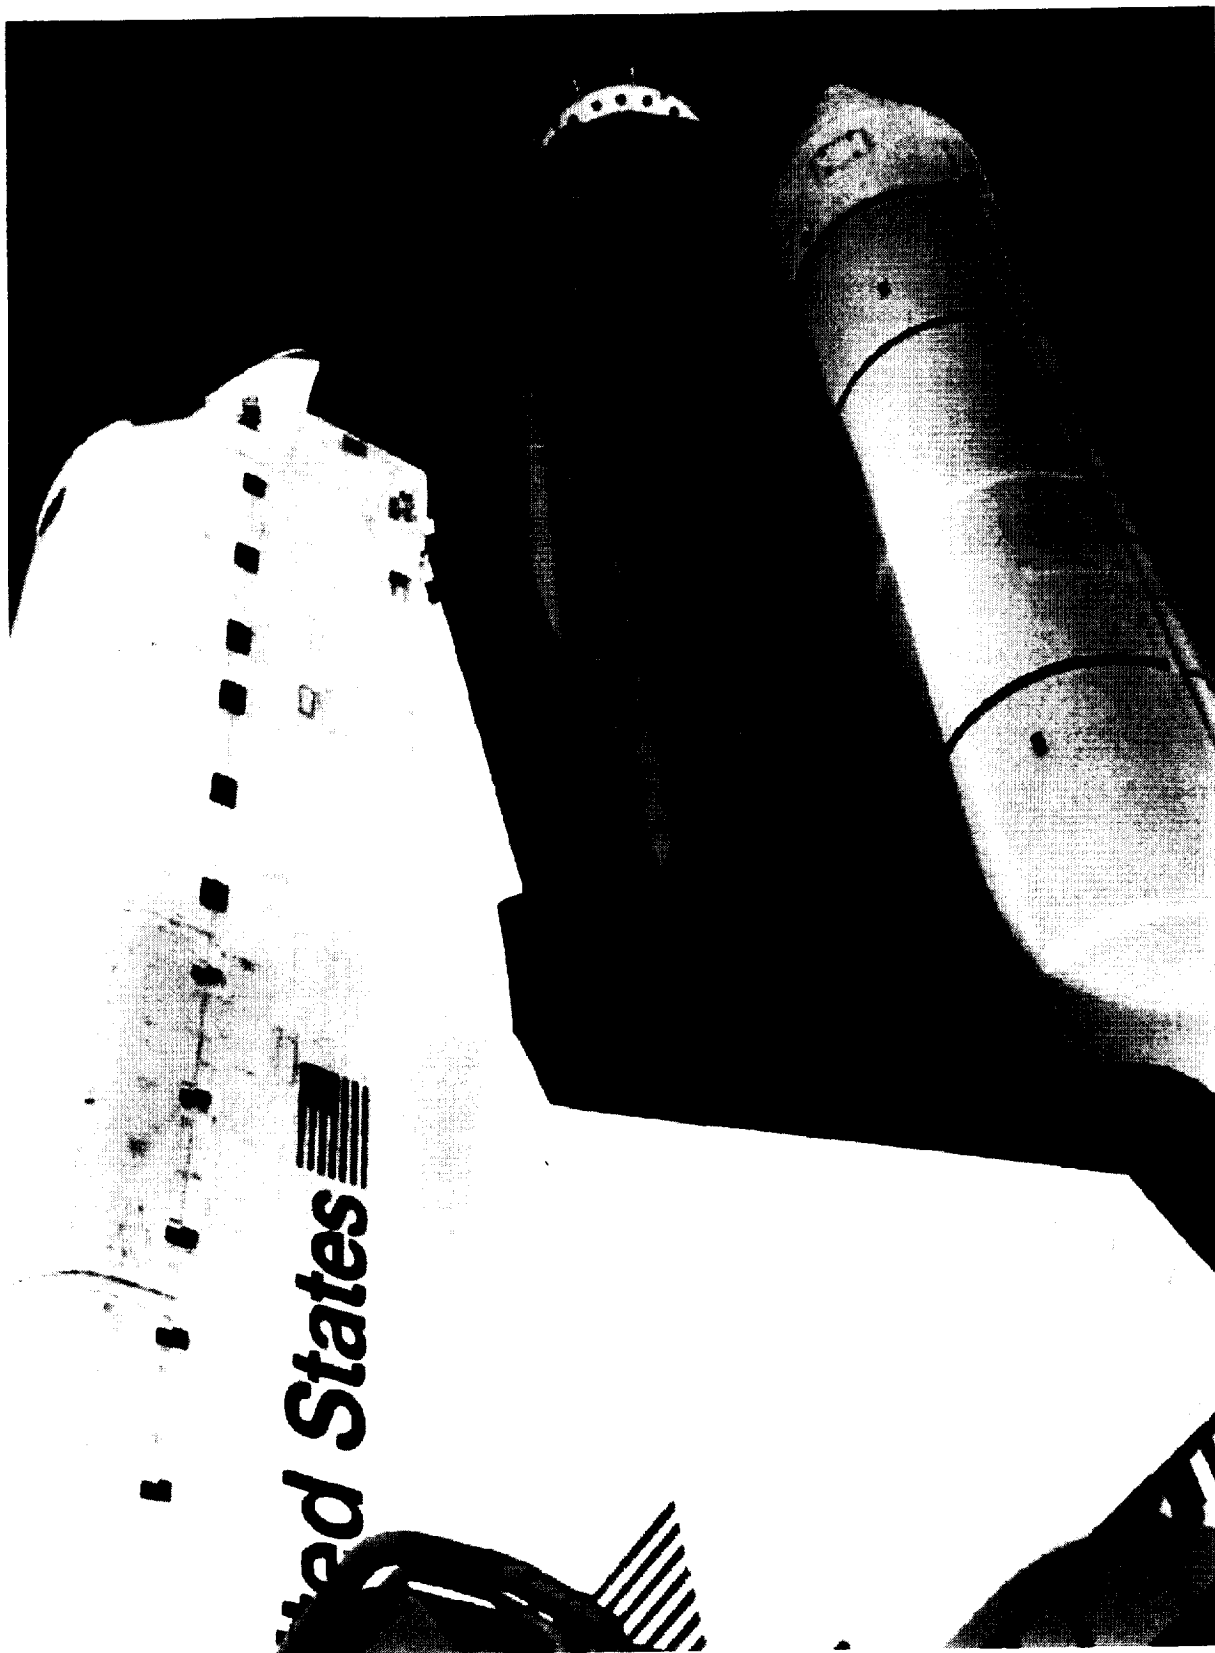
**Photo 6: LH2 Tank Acreage**

Light condensate was present on the LH2 tank acreage. Surface temperatures ranged from 58 to 66 degrees Fahrenheit. There were no acreage TPS anomalies.

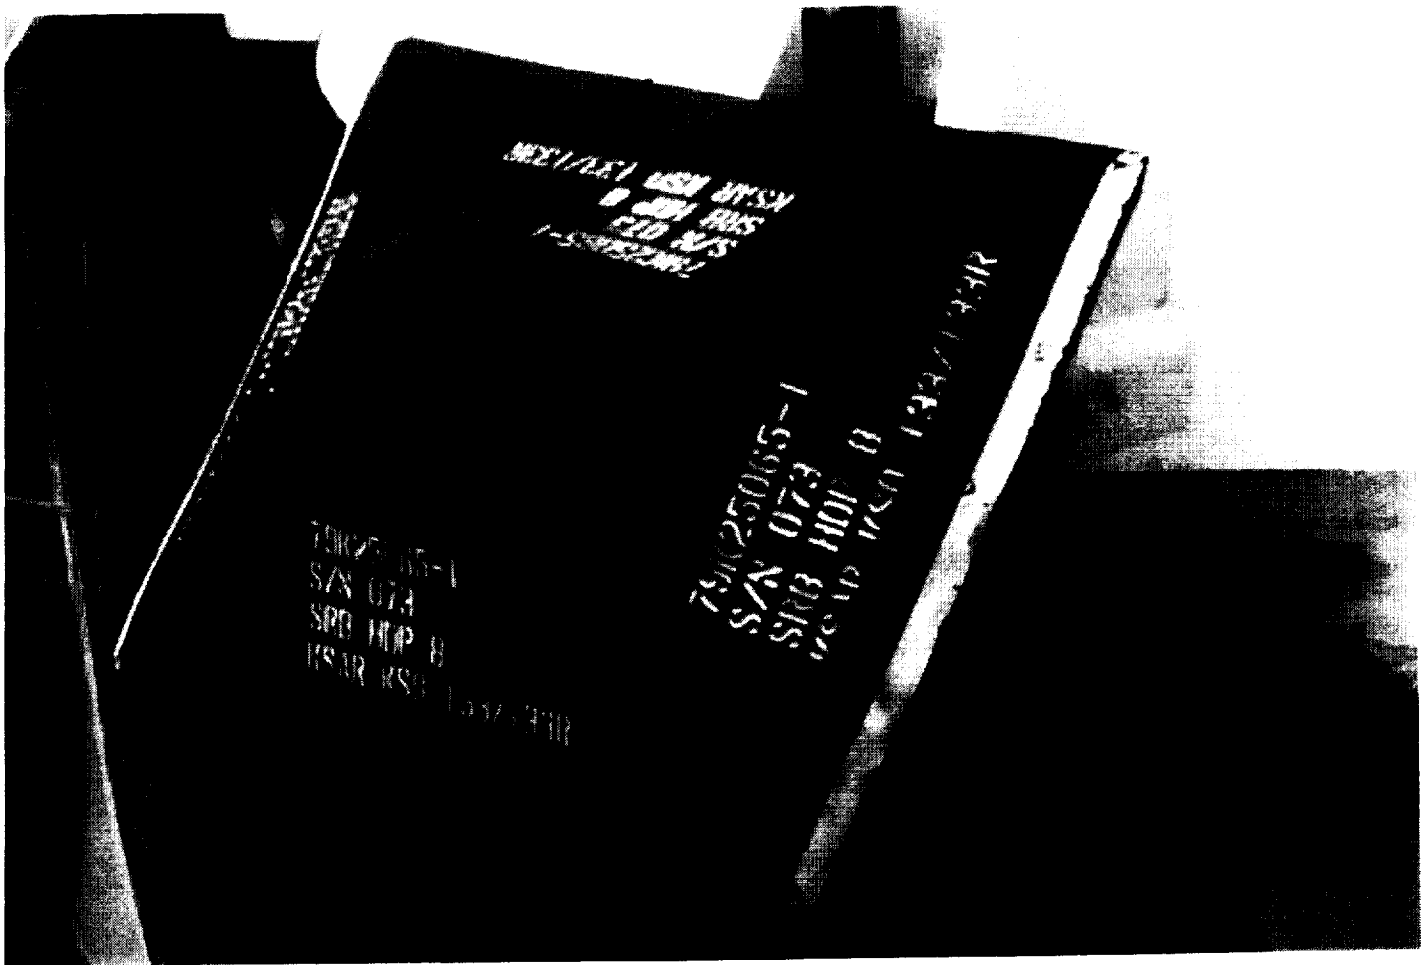
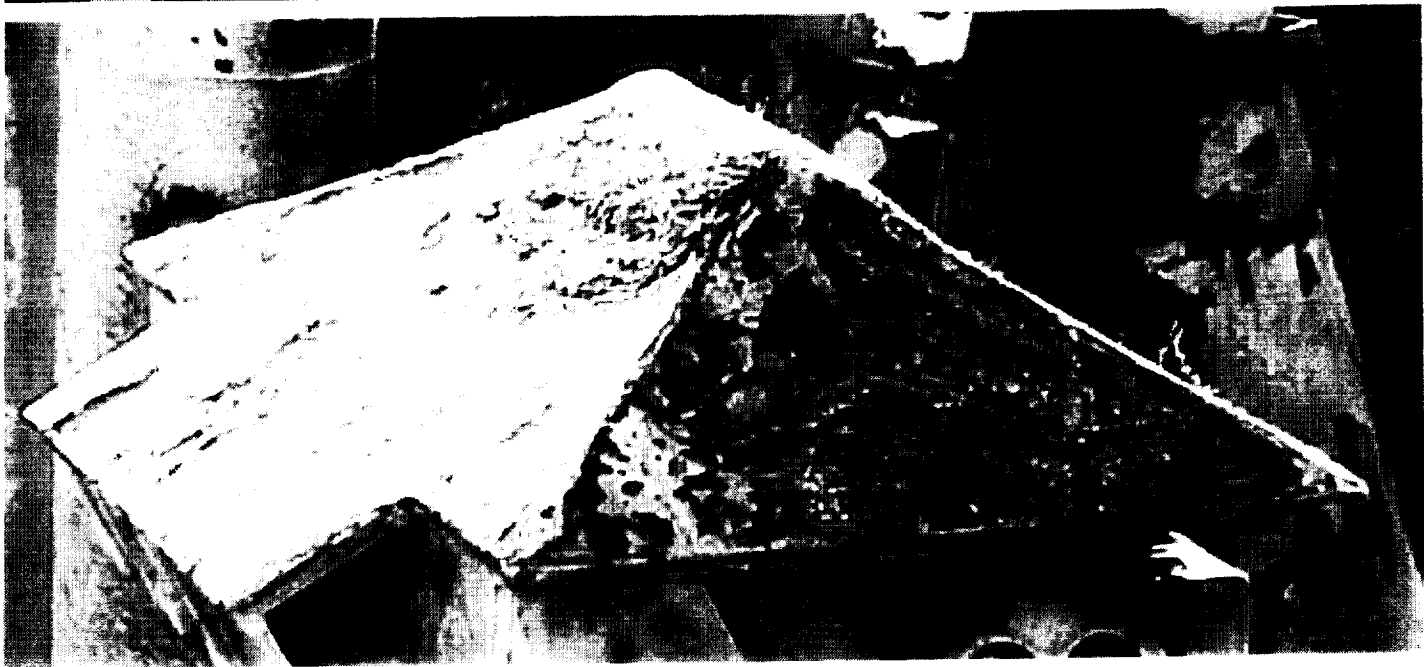
**Photo 11: HDP #8 Blast Cover Coating**

The blast cover for HDP #8 was modified with an ablative test coating material to protect the steel cover from SRB plume erosion. The material ablated as designed with no apparent damage to the steel cover.

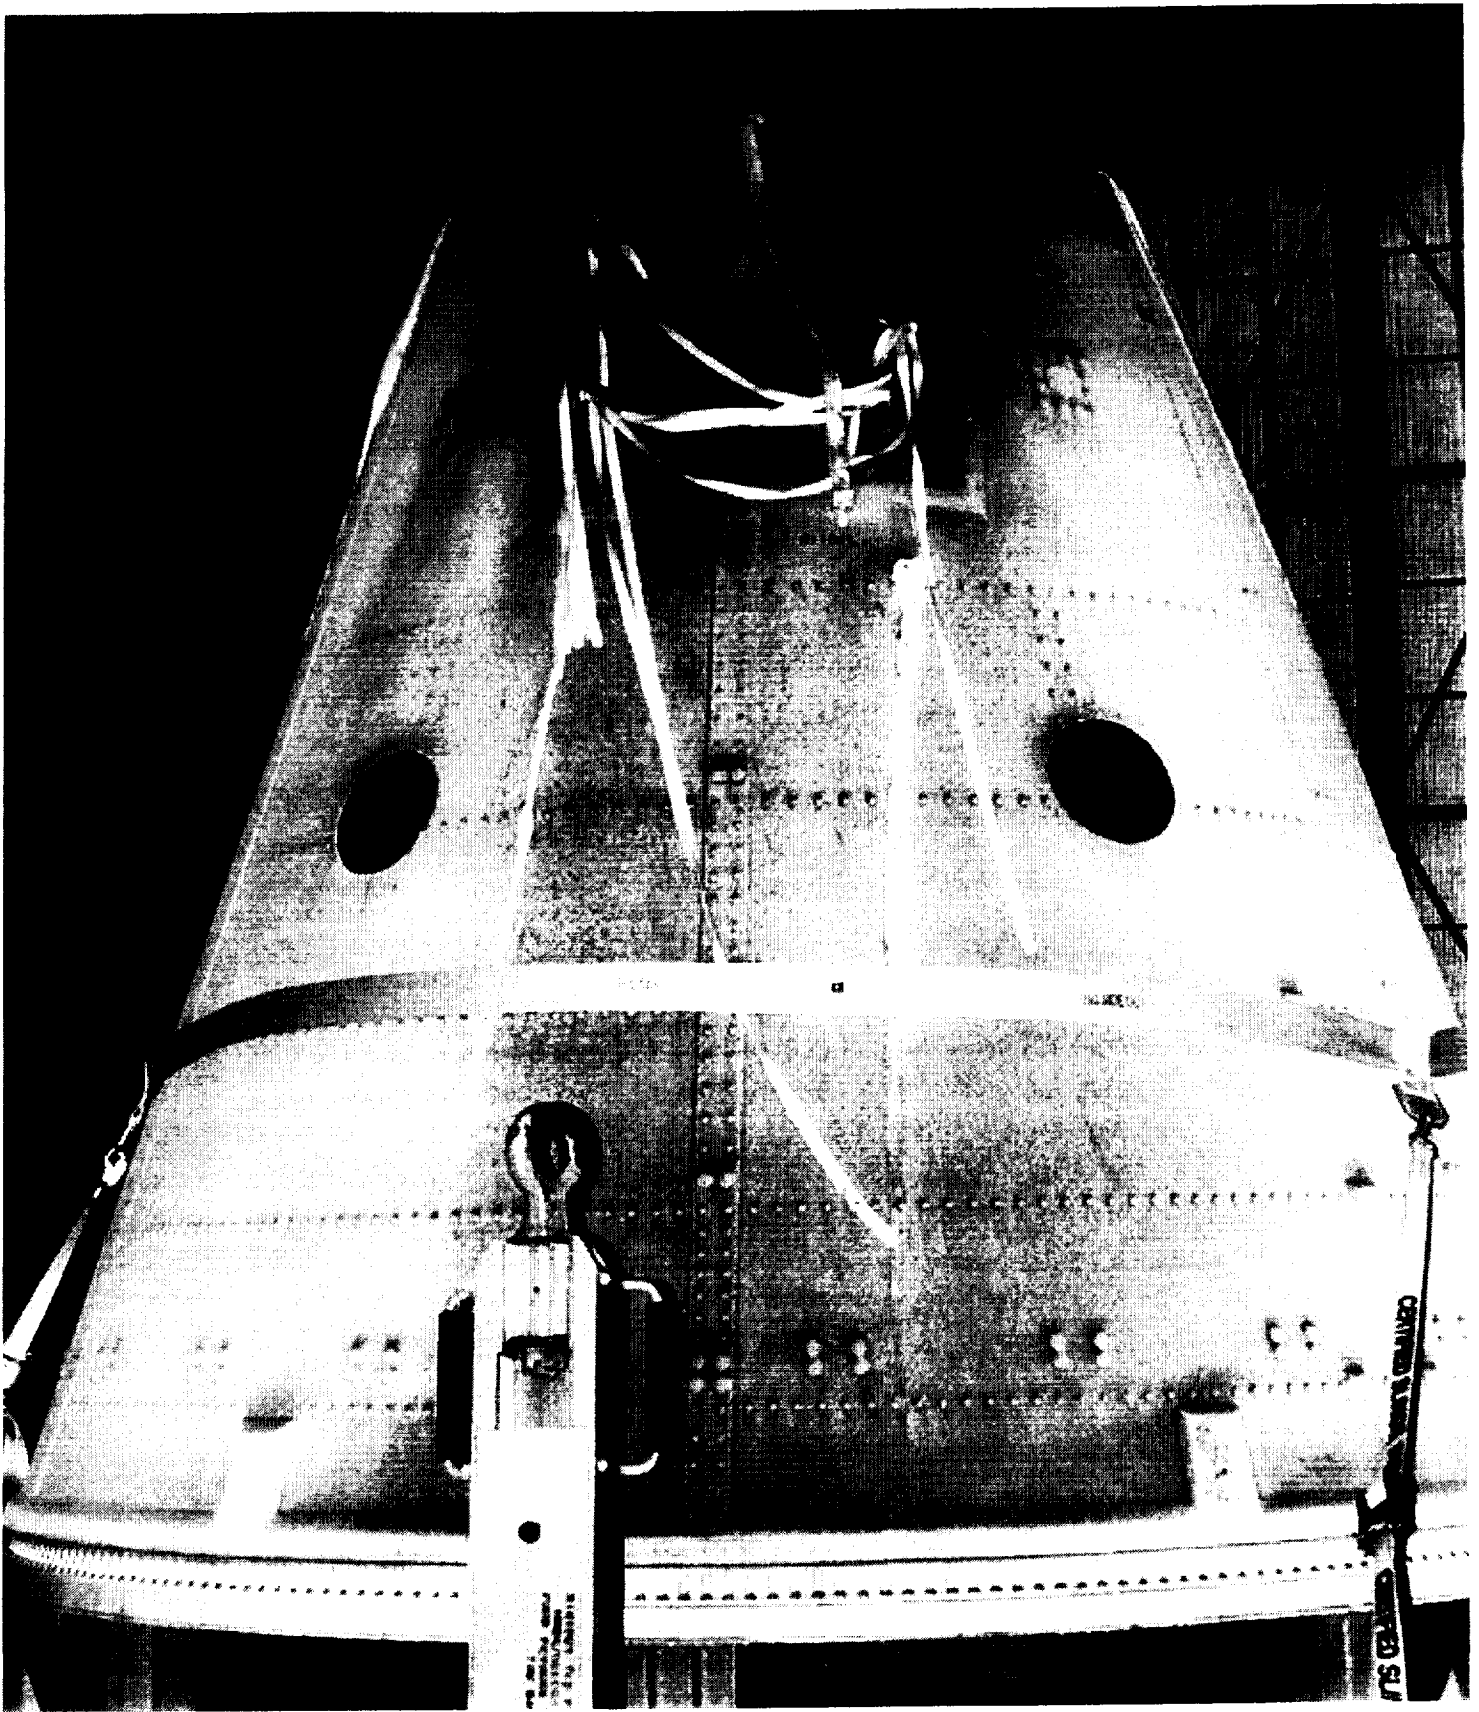
**Photo 26: Frustum Post Flight Condition**

The frustums exhibited no debonds/unbonds or missing TPS.  
All eight BSM aero heat shield covers had locked in the fully opened position.

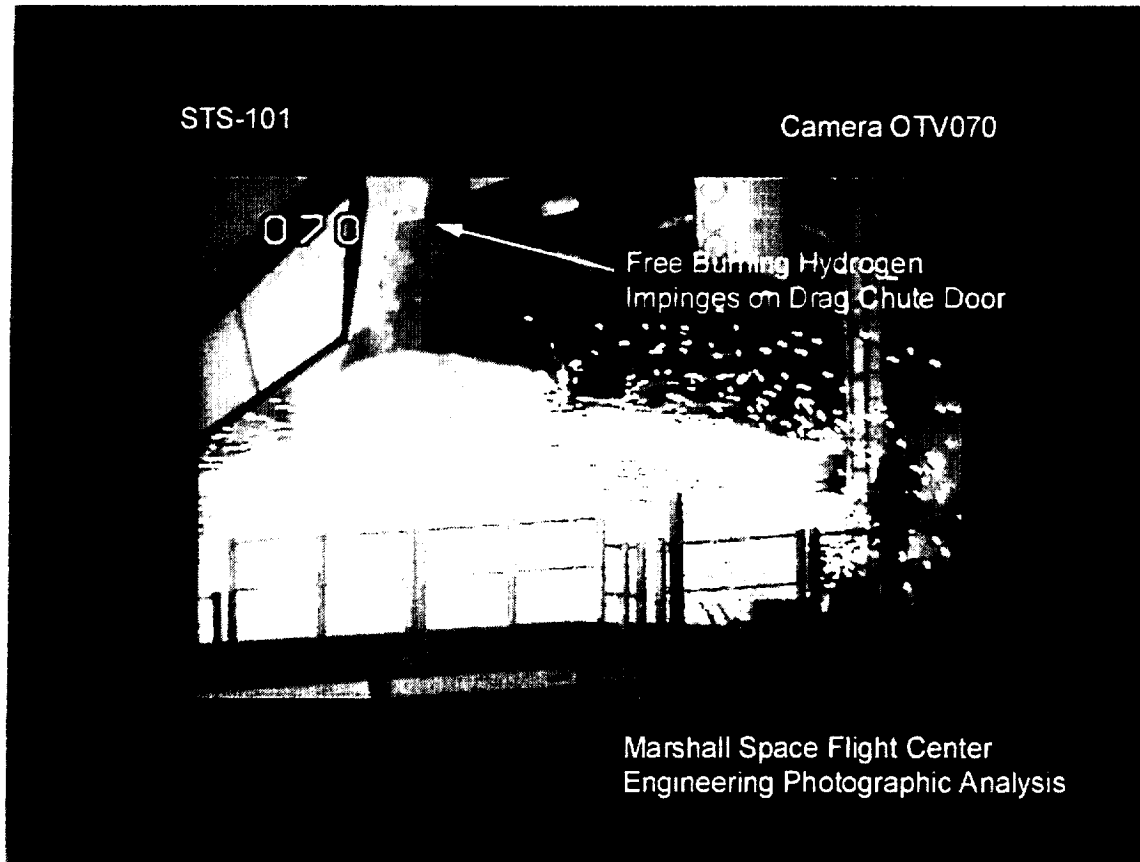
**Figure 1. Free Burning Hydrogen at SSME Start-Up**

Free burning Hydrogen was observed, as a glowing reddish-orange gas, at engine start-up. This is a typical occurrence at start-up. The free burning Hydrogen was noted in this instance to impinge on the drag chute door as shown in the figure below.

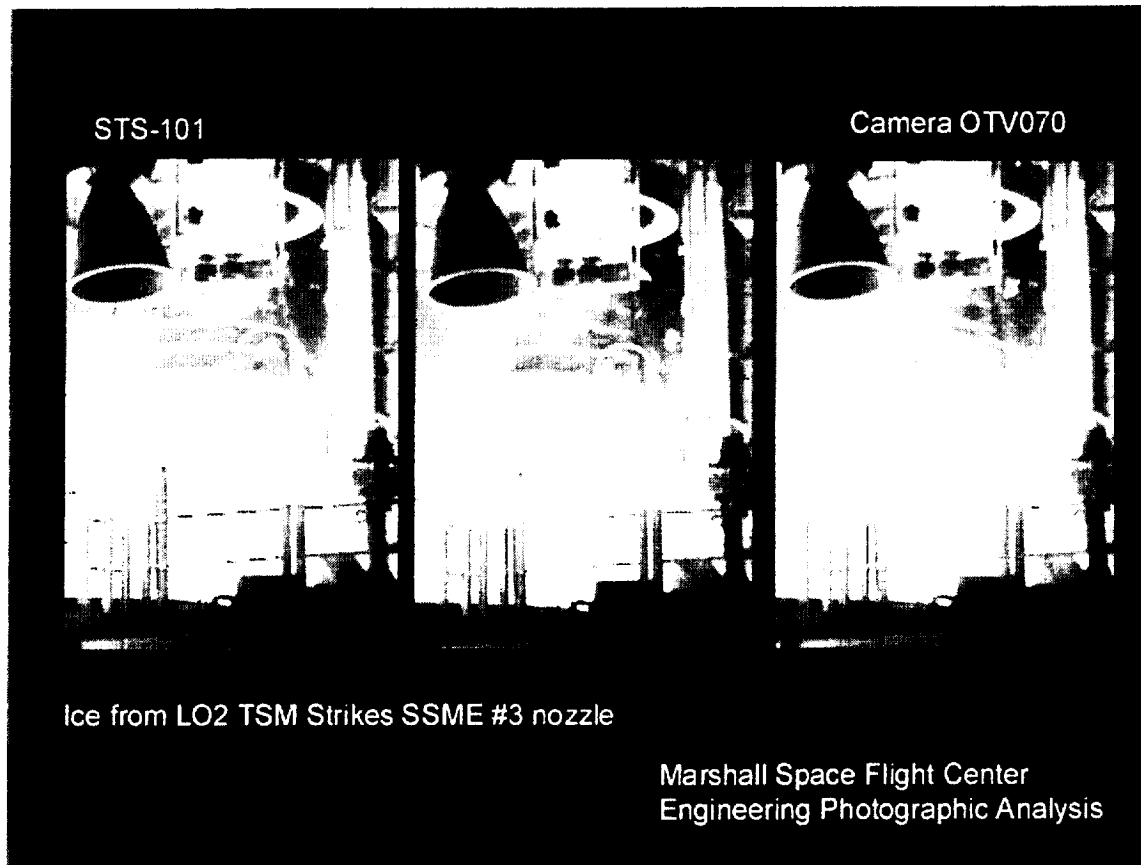
**Figure 2. Ice Strikes SSME#3 Nozzle**

Two pieces of ice debris from the LO2 TSM impacted SSME#3 nozzle near the eighth hatband. Images below show one of the ice masses impacting SSME#3 nozzle and breaking apart. No damage to the nozzle was observed from either ice impact.

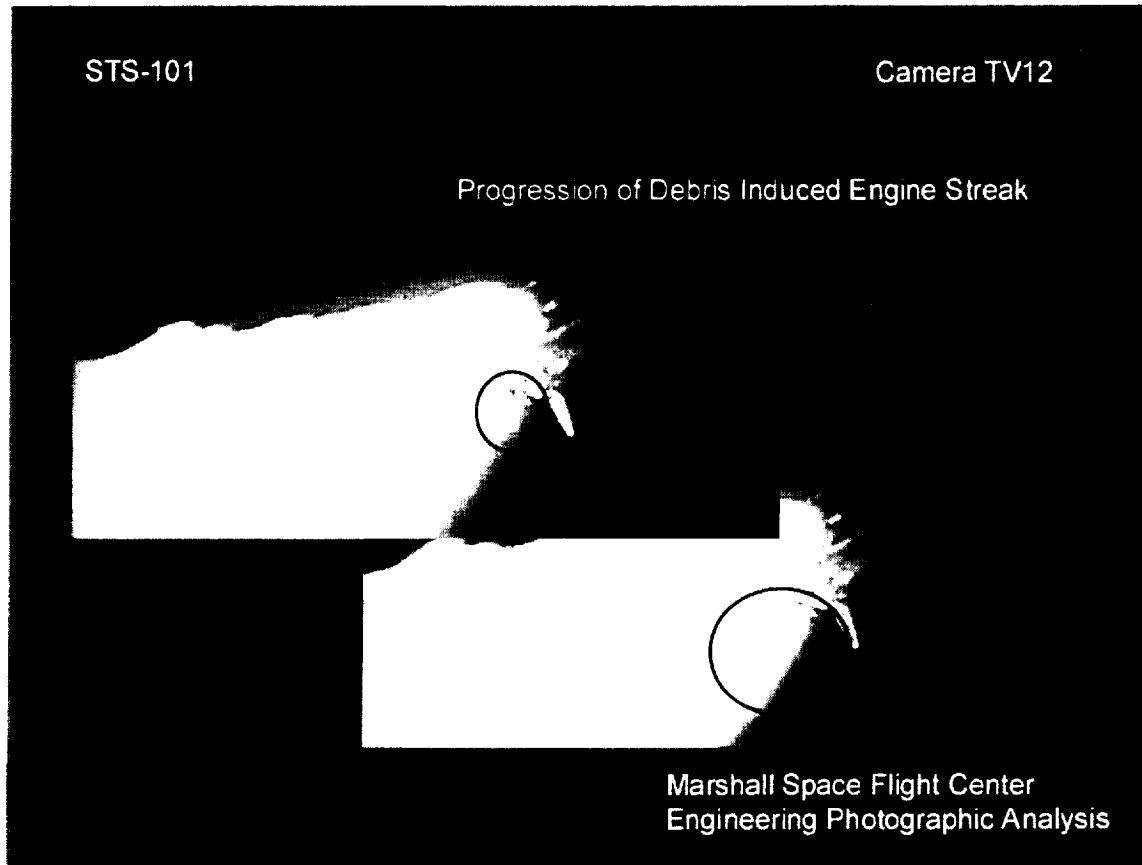
**Figure 3. Debris Induced Streak Observed by Video Camera TV-12**

A view from video camera TV12 of the debris induced streak in the SSME plumes. These debris induced streaks are typically the result of butcher paper or purge barrier material falling into a plume.

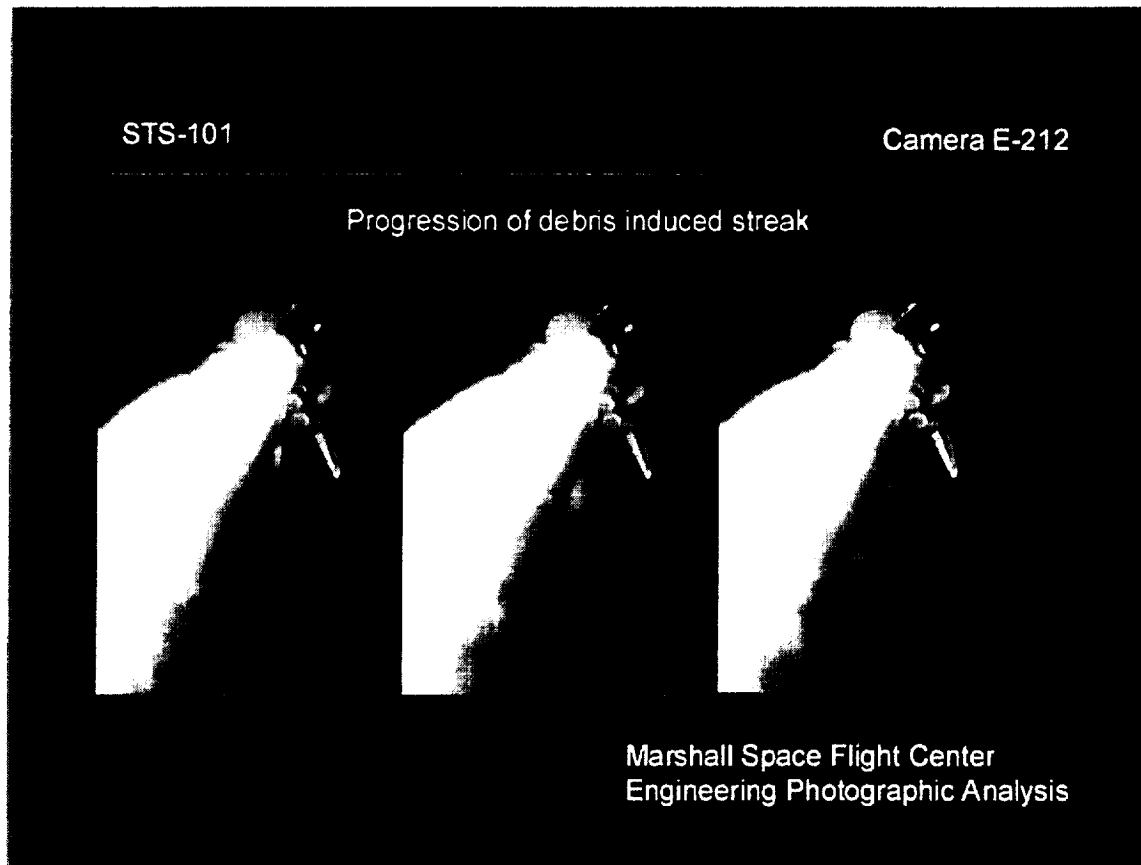
**Figure 4. Debris Induced Streak Observed by Film Camera E212**

A sequence of frames from the 35mm Film Camera E212 showing the debris induced streak originating in the SSME plumes. This is the same streak as shown in figure 3. The film cameras typically give better resolution of events. In the sequence of frames below, the streak can be seen originating in the plume at a distance from the nozzle. This separation from the nozzle exit plane is an indicator that a streak is caused by debris falling into the plume.

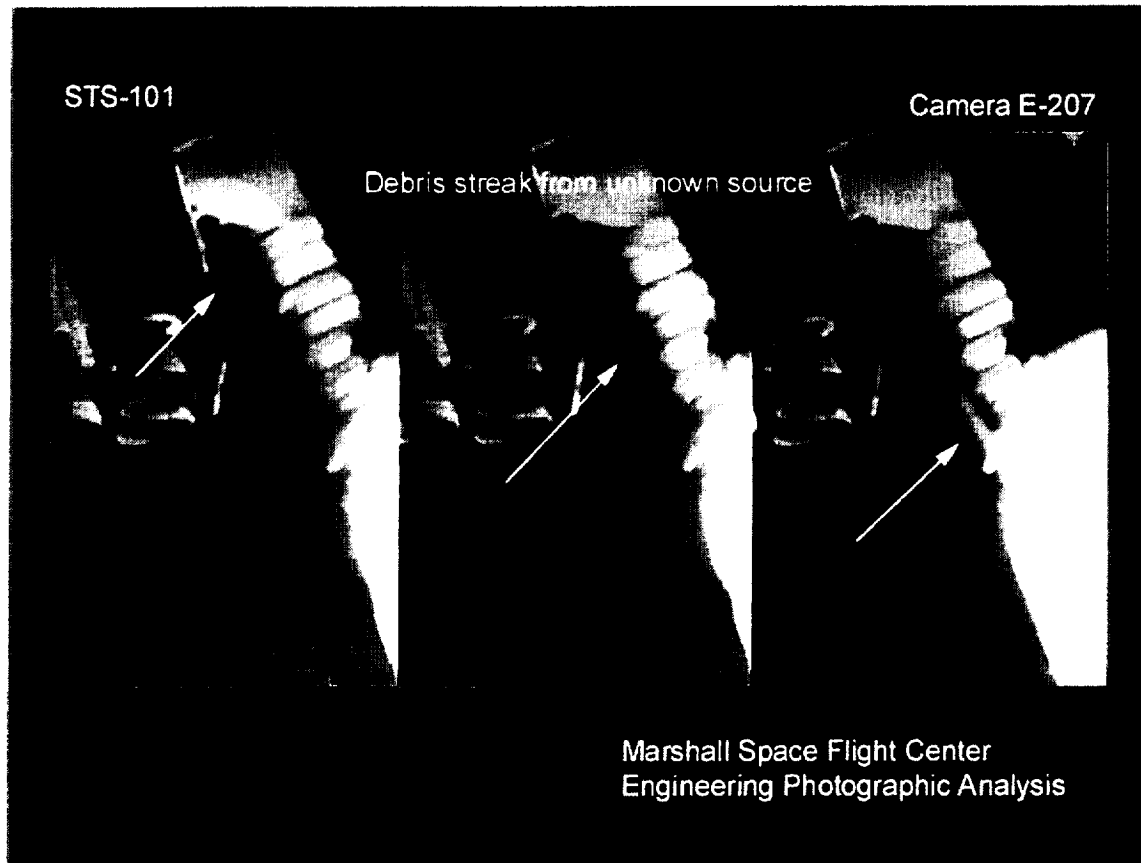
**Figure 5. Debris Streak Observed by Film Camera E207**

A sequence of images from the 35mm Film Camera E207 that shows debris of unknown origin that caused a streak, not associated with plume streaking, which appears to be located near orbiter between inboard orbiter elevon and right SRB. This event was timed at 140:10:11.44.148 UTC. A similar event occurred on STS-26. The STS-26 event was identified as debris from tiles. Inspection of tiles after landing revealed a damage site which is suspected as the cause of this streak.
